Central Queens Branch of the Prince Edward Island Wildlife Federation
West River Atlantic Salmon Habitat Management Strategy

2022 Update

Atlantic Salmon Habitat Management Plan for West River

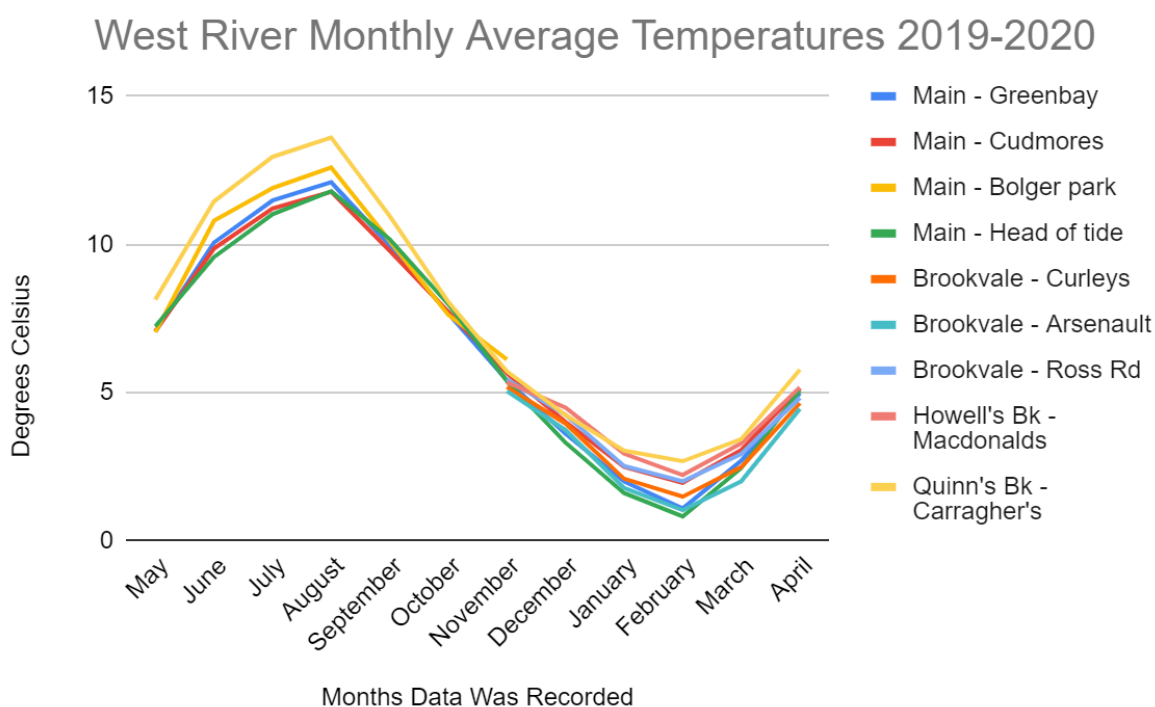
Figure 2. Monthly temperature averages on the West River at 9 locations from May 2019 to April 2020.

Water temperature: Temperature data loggers were installed at 9 sites throughout the West River to monitor annual temperature regimes in 2019 and 2020 (Figure 6). Gaps in data in Figure 2 were because in 2020 there was one logger that went missing and another two loggers stopped working. The highest recorded temperature for 2020 was 18.4 degrees Celsius on August 14th. The highest recorded temperature for 2019 was 16.9 degrees Celsius on July 30. Figure 2 displays the monthly temperature average from May 2019 to April 2020.

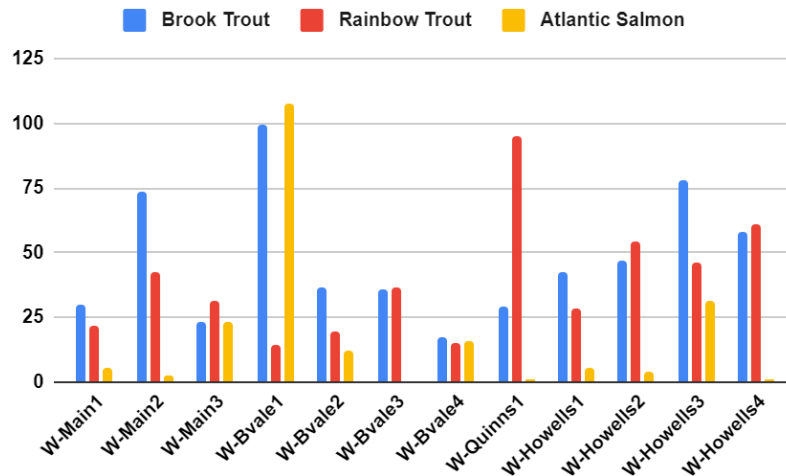
Figure 5. Electrofishing data from 2020 at eight sites on the West River showing salmonid density per 100m².

Electrofishing data: In 2022, 12 index sites were surveyed for salmonid densities (Figure 5). A three-pass technique was used with barrier nets at all sites. The data is presented below in Figure 5. Atlantic salmon were present at all sites except for the Skye Brook site with densities ranging from 0.7 - 107.3 per 100 m². Atlantic salmon's average density was 10.1 fish per 100 m² in 2022 for the 12 sites surveyed.

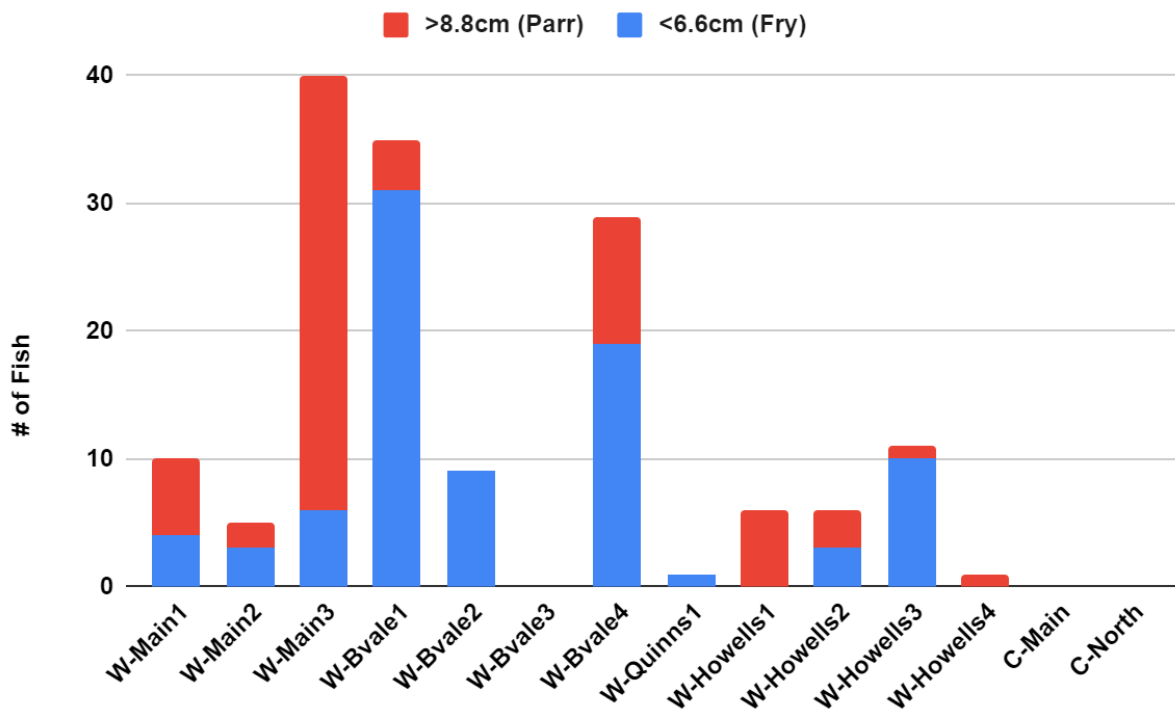
Figure 6. Comparison between the number of young of the year (>8.6mm) and parr (<6.6cm) during electrofishing surveys in 2022.

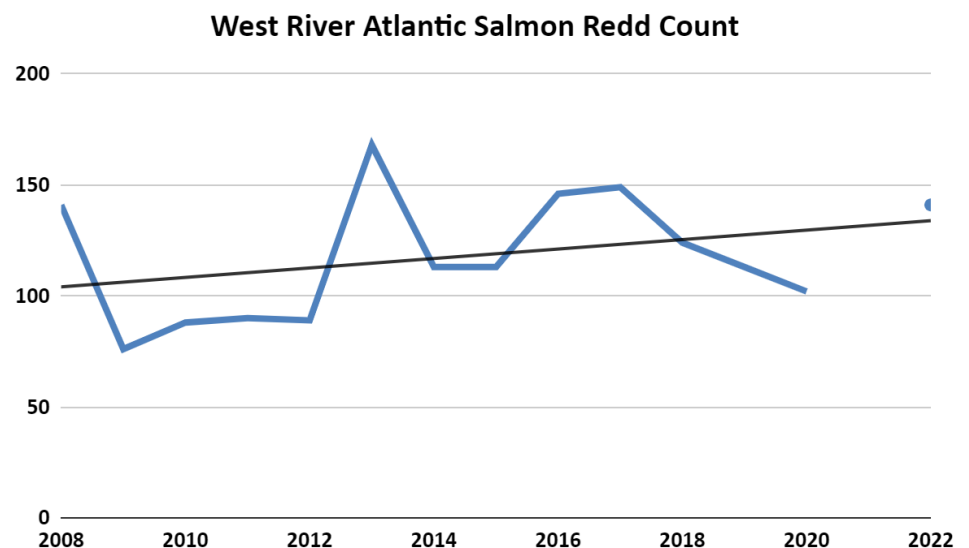
Figure 7. Salmon redd count surveys on the West River since 2010 (* indicates an incomplete count).

Annual redd surveys have also been conducted for Atlantic salmon on the West River from 1990 – 96 and 2008 – 21; while conducting redd surveys, trout spawning areas and other critical habitats were always noted. Table 2 displays Atlantic salmon redds counted from 2010 to 2022. All major tributaries are surveyed along with the entire main branch. In recent years salmon redds have been found in areas that are newly restored and this is encouraging as they are responding in a positive manner to restoration activities. It is important to record the total number of redds but also the areas in which spawning occurs to further target management activities.
