**Central Queens Branch of the Prince Edward Island Wildlife Federation  
Renewed West River Atlantic Salmon Habitat Management Strategy**

Prepared by Knowlton Parkman and Isaac Arsenault-Saunders

2025

## Atlantic Salmon Habitat Management Plan for West River

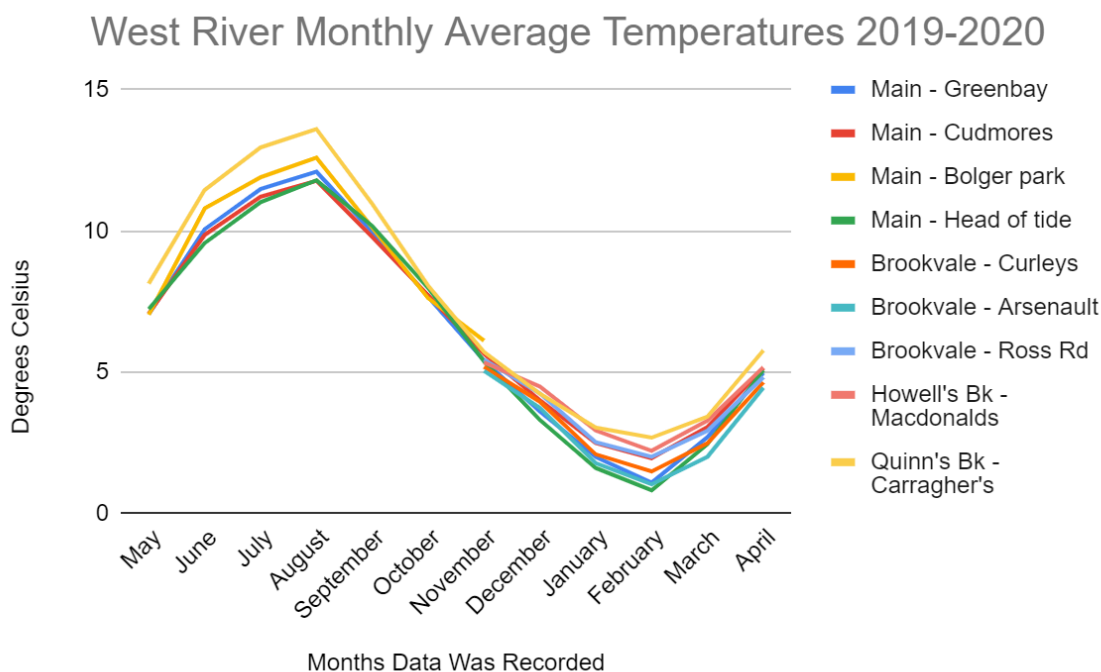
**Figure 2.** Monthly temperature averages on the West River at 9 locations from May 2019 to April 2020. **Nitrate monitoring:** On major tributaries, nutrient concentrations were monitored twice annually; once during low and high flow periods (Figures 3 and 4). In total 10 index sites are monitored on the West River (Figure 6).

**Water temperature:** Temperature data loggers were installed at 9 sites throughout the West River to monitor annual temperature regimes in 2019 and 2020 (Figure 6). Gaps in data in Figure 2 were because in 2020 there was one logger that went missing and another two loggers stopped working. The highest recorded temperature for 2020 was 18.4 degrees Celsius on August 14th. The highest recorded temperature for 2019 was 16.9 degrees Celsius on July 30. Figure 2 displays the monthly temperature average from May 2019 to April 2020.

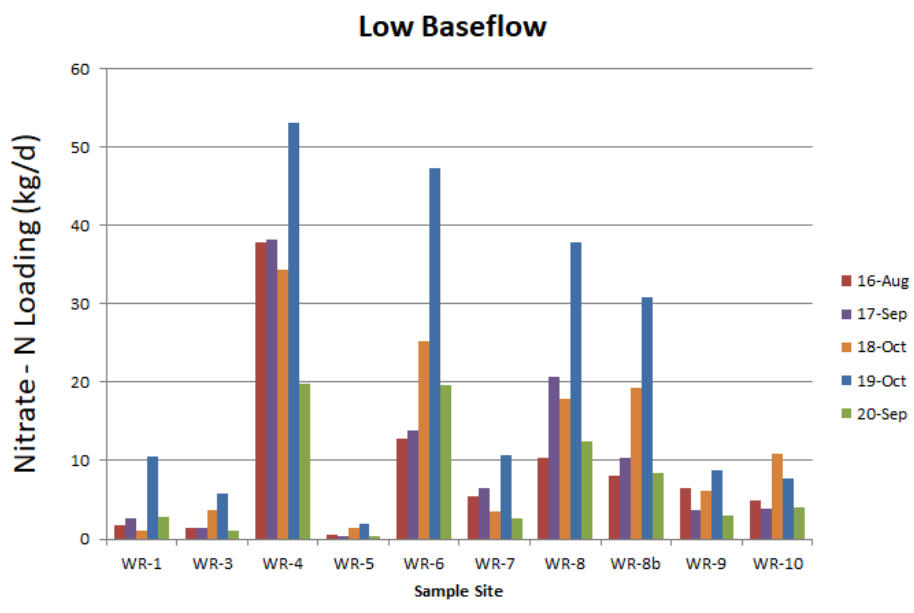
**Figure 3.** Site comparison of nitrate loading during fall season low flow period on the West River from 2016-2020.

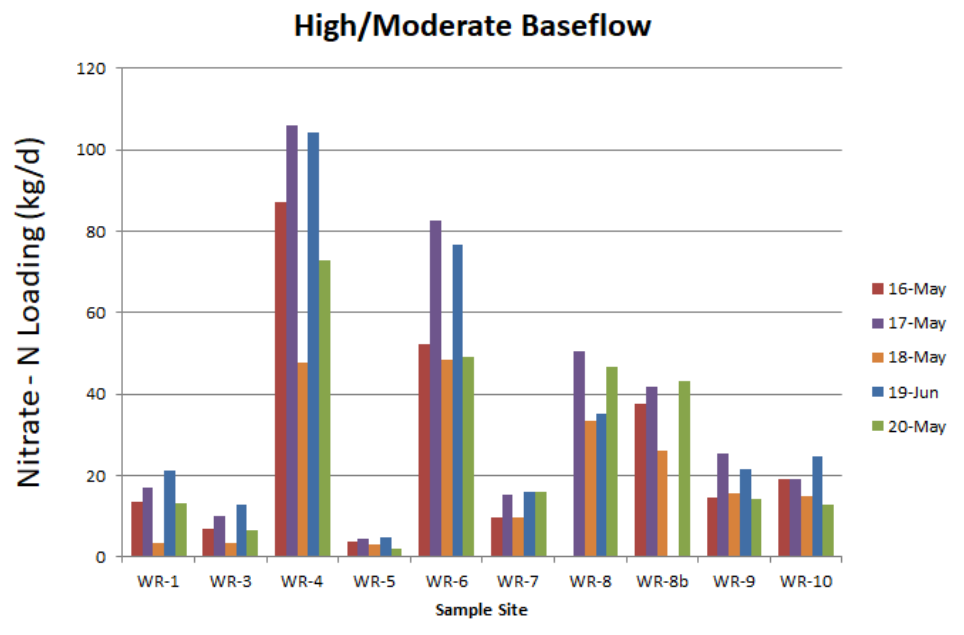
**Figure 4.** Site comparison of nitrate loading during fall season-high/moderate flow period on the West River from 2016-2020.

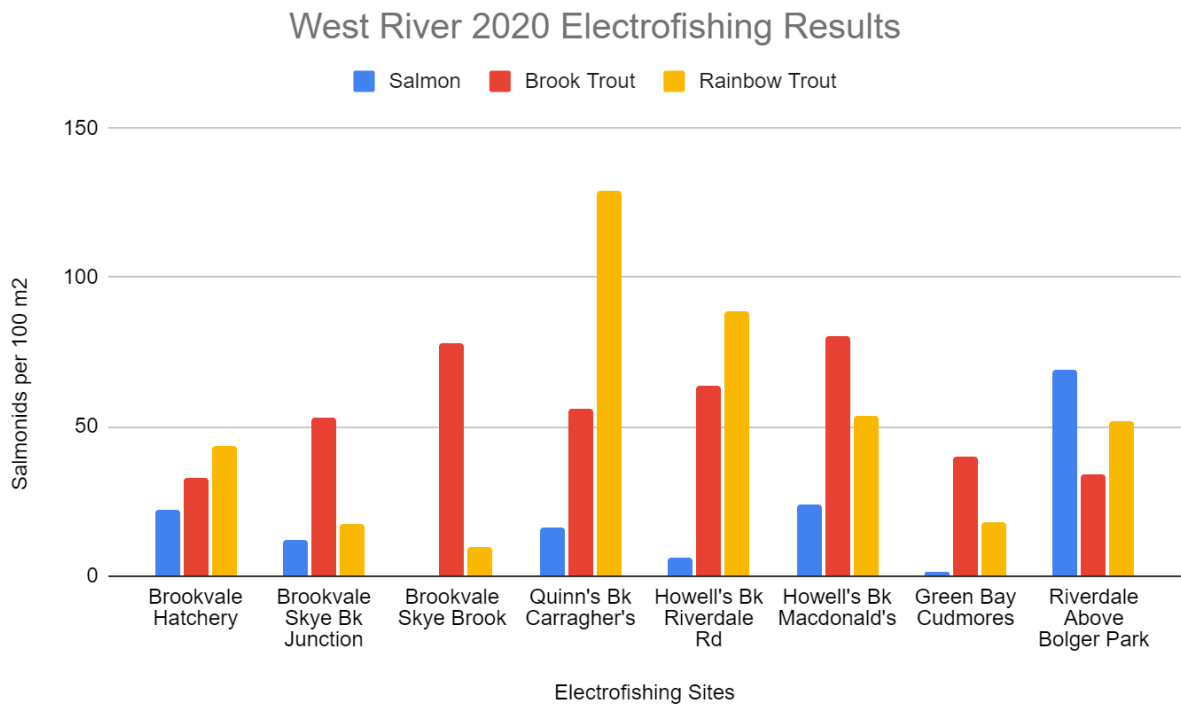
**Figure 5.** Electrofishing data from 2020 at eight sites on the West River showing salmonid density per 100m<sup>2</sup>.

**Electrofishing data:** In 2025 thirteen index sites were surveyed for salmonid densities (Figure 5). A three-pass technique was used with barrier nets at all sites except the Howells Junction site. The data is presented below in Figure 5. Atlantic salmon were present at all sites except for the Skye Brook site with densities ranging from 0 - 68.9 per 100 m<sup>2</sup>.
